# Inspection Report

Your House Next To The Creek  
Mountain Town, CO. 99999

Prepared for: Ryan Hunter

Prepared by: Above All Home Inspections, LLC  
PO Box 695  
Buena Vista, CO 81211-0695

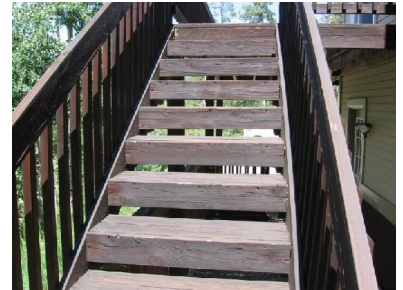
| 3. Category 2 | <b>Steps/Stoops:</b> Wood- Steps bow and sag as they are walked on. Condition may be due to weathered wood and/or weakening wood. A qualified contractor is recommended to evaluate and estimate repairs |

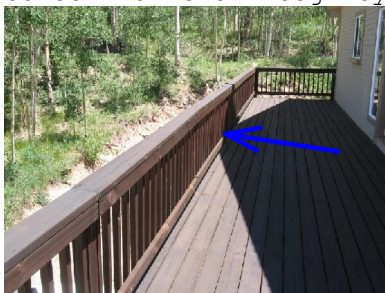
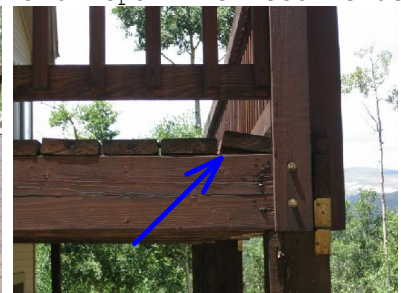
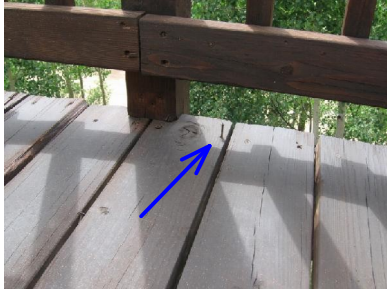
| 4. Category 2 | <b>Deck:</b> Stained wood- Loose railing at deck and stairs, this condition can lead to future failure of the railing and provides a false sense of security. A qualified contractor is recommended to evaluate and estimate repairs. Twisted deck board and loose screws noted at deck, these items do not pose a immediate concern of the integrity of the deck, maintenance and repair is recommended. |

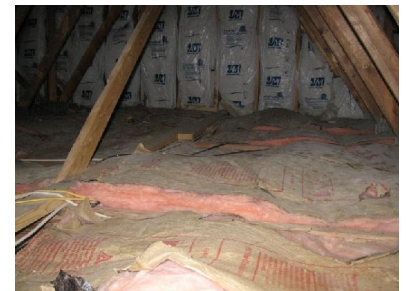
6. Category 2      **Insulation:** Fiberglass- Improper installation of insulation. Per manufacturer's recommendation insulation vapor barrier must be installed towards the living space, currently the insulation is installed with the kraft paper (vapor barrier) facing away from the living space. Recommend correct placement and installation of insulation.

3. **Main Attic Insulation:** Fiberglass- Improper installation of insulation. Per manufacturer's recommendation insulation vapor barrier must be installed towards the living space, currently the insulation is installed with the kraft paper (vapor barrier) facing away from the living space. Recommend correct placement and installation of insulation.

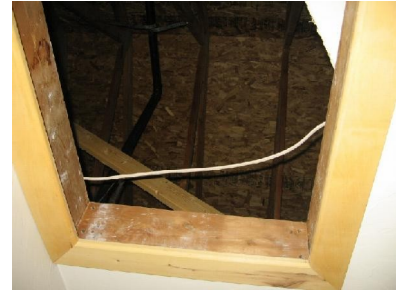
- 7. Acceptable      **Insulation Depth:** 8"
- 8. Acceptable      **Vapor Barrier:** Paper- See notes at insulation.
- 9. Category 3      **Wiring/Lighting:** 120 VAC lighting circuit- Wires are ran on top of attic access, recommend relocating wires.

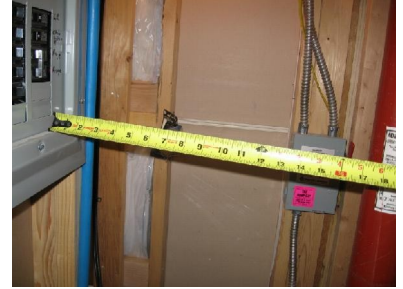
16. Category 2 **Manufacturer:** Cutler-Hammer- Improper clearance in front of electrical panel, 36" is recommended for safety, fire, and service access. Evaluation by a qualified contractor is recommended.

4. **Basement Electric Panel Manufacturer:** Cutler-Hammer- Improper clearance in front of electrical panel, 36" is recommended for safety, fire, and service access. Evaluation by a qualified contractor is recommended.

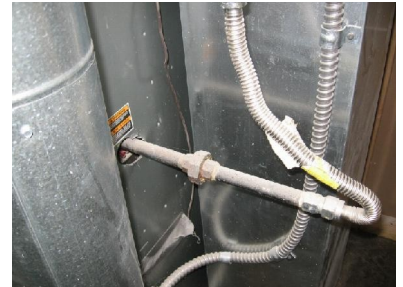
15. **Acceptable Thermostats:** At hallway at Top Level  
16. **Category 3 Gas Line Rigid Pipe, Flex Line-** No drop leg present before appliance. A properly installed drop leg will act as a sediment and moisture trap, therefore collecting sediment before it travels to the burner of the appliance causing clogged burners or other maintenance problems from occurring. Recommend installing drop leg. A qualified contractor is recommended to evaluate and estimate repairs.

5. **Gas Line** Rigid Pipe, Flex Line- No drop leg present before appliance. A properly installed drop leg will act as a sediment and moisture trap, therefore collecting sediment before it travels to the burner of the appliance causing clogged burners or other maintenance problems from occurring. Recommend installing drop leg. A qualified contractor is recommended to evaluate and estimate repairs.

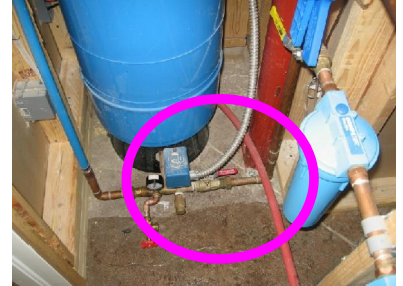
- 1. Acceptable Service Line: Copper
- 2. Acceptable Main Water Shutoff: Basement, Utility closet

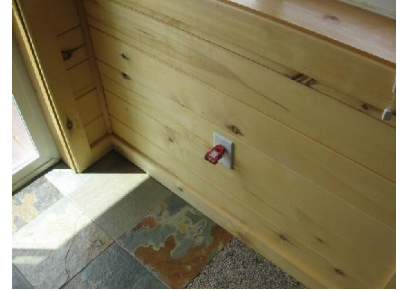
6. Category 2 **Electrical:** 120 VAC outlets and lighting circuits- Loose switch or outlet, Recommend repair or replacement.

5. **Living Room, 2nd Floor Living Space Electrical:** 120 VAC outlets and lighting circuits- Loose switch or outlet, Recommend repair or replacement.

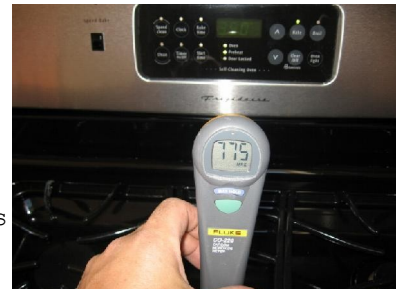
1. Category 1 **Cooking Appliances:** General Electric- Oven operation produced excessive amounts of CO (Carbon Monoxide), 775ppm of CO was detected, readings of 100ppm are considered by the U.S. Department of Labor, Occupational Safety & Health Administration to be an exposure limit. This oven is producing a dangerous level of CO. A qualified contractor is recommended to evaluate and estimate repairs. Note: At high elevations (Above 6,000ft from sea level) it is a common occurrence for ovens and gas appliances to be maladjusted for the lower amounts of oxygen present in the air and excessive fuel is being supplied to the burners causing CO to be produced by incomplete combustion, adjustment may be needed.
2. Acceptable **Ventilator:** General Electric, Over the Range

2. **2nd Floor Kitchen Cooking Appliances:** General Electric- Oven operation produced excessive amounts of CO (Carbon Monoxide), 775ppm of CO was detected, readings of 100ppm are considered by the U.S. Department of Labor, Occupational Safety & Health Administration to be an exposure limit. This oven is producing a dangerous level of CO. A qualified contractor is recommended to evaluate and estimate repairs. Note: At high elevations (Above 6,000ft from sea level) it is a common occurrence for ovens and gas appliances to be maladjusted for the lower amounts of oxygen present in the air and excessive fuel is being supplied to the burners causing CO to be produced by incomplete combustion, adjustment may be needed.

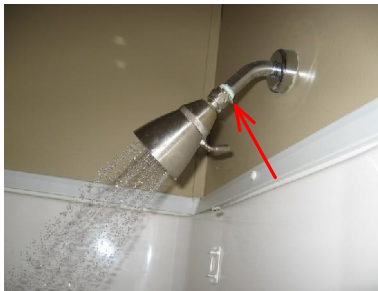
1. Acceptable **Ceiling:** Drywall, Textured, and Painted  
 2. Acceptable **Walls:** Drywall, Textured, and Painted  
 3. Acceptable **Floor:** Tile  
 4. Acceptable **Doors:** Wood  
 5. Acceptable **Electrical:** 120 VAC outlets and lighting circuits- All outlets are GFCI protected  
 6. Acceptable **Sink/Basin:** Pedestal  
 7. Category 1 **Faucets/Traps:** Standard- Leaking drain beneath vanity at p-trap, Leaking shower head, A qualified contractor is recommended to evaluate and estimate repairs.

4. **1st Floor Main Bathroom Faucets/Traps:** Standard- Leaking drain beneath vanity at p-trap, Leaking shower head, A qualified contractor is recommended to evaluate and estimate repairs.

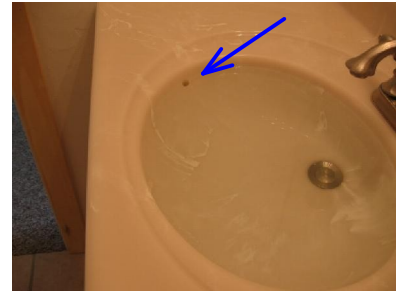
- 24. Acceptable Closet: Walk In
- 25. Acceptable Ceiling: Drywall, Textured, and Painted
- 26. Acceptable Walls: Drywall, Textured, and Painted
- 27. Acceptable Floor: Tile
- 28. Acceptable Doors: Wood
- 29. Acceptable Windows: Vinyl slider
- 30. Acceptable Electrical: 120 VAC outlets and lighting circuits- All outlets are GFCI protected
- 31. Acceptable Counter/Cabinet: Laminate and wood
- 32. Category 3 Sink/Basin: Molded single bowl- Overflow does not have adequate drainage, recommend clearing or repairing overflow drain.

6. **2nd Floor, Master Bathroom Sink/Basin:** Molded single bowl- Overflow does not have adequate drainage, recommend clearing or repairing overflow drain.

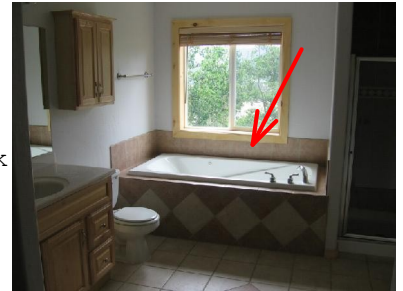
- 33. Acceptable Faucets/Traps: Standard
- 34. Acceptable Shower/Surround: Tile, Glass Surround
- 35. Not Inspected Spa Tub/Surround: Fiberglass tub and tile surround- No presence of a service access panel for pump and electrical service was identified. A GFCI circuit was not identified for spa tub at inspection. Recommend verifying with the seller if access is present to the electrical and mechanical components of the tub and ask to verify the presence of the electrical to be protected by an GFCI circuit. Also a qualified contractor is recommended to evaluate and estimate repairs.

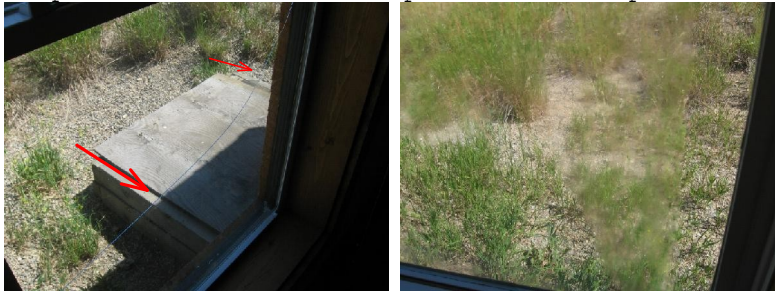
- 1. Acceptable **Closet:** Large
- 2. Acceptable **Ceiling:** Drywall, Textured, and Painted
- 3. Acceptable **Walls:** Drywall, Textured, and Painted
- 4. Acceptable **Floor:** Carpet
- 5. Acceptable **Doors:** Wood
- 6. Category 1 **Windows:** Vinyl slider- Broken glass, Moisture present inside the layers of glass, this is an indication that the seal between the two panes of glass is compromised. Recommend repair and/or replacement.

5. **2nd Floor, Guest #1, East Bedroom Windows:** Vinyl slider- Broken glass, Moisture present inside the layers of glass, this is an indication that the seal between the two panes of glass is compromised. Recommend repair and/or replacement.

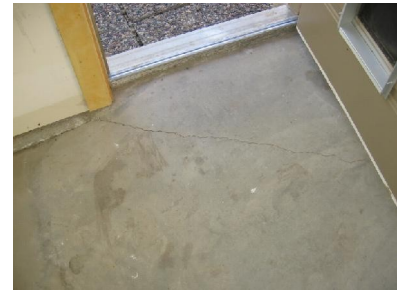
| 8. Acceptable | <b>Floor/Foundation:</b> Poured slab- Settling crack noted in garage, No displacement or movement noted |
